# The Degree of Success in Environmental Mitigation Measures of Development Projects in Sri Lanka with Special Reference to Peraru Water Supply and Sanitation Project

Y.B.M. Asmi<sup>1</sup> and T.K. Weerasinghe<sup>2</sup>

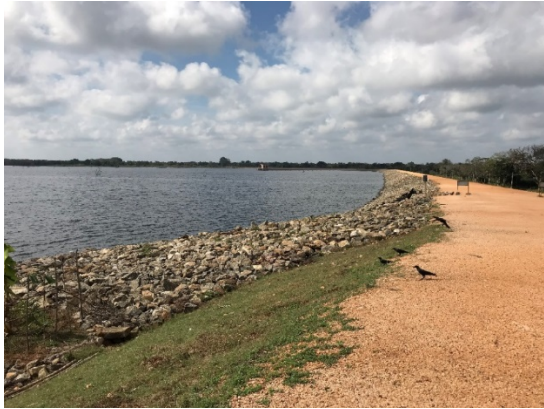
Soil erosion may take place along the bund slopes by forming runnels. Figure 5 shows cascade type drainage lines constructed along the bund slopes to drain out the surface water collected over the bund surface during heavy rains. The impact has been reduced by turfing in the downstream slope and providing the riprap protection on the upstream section (Fig 5 and Fig 6). The project staff confirmed that some turbidity was observed in the downstream during the rainy season. During the monsoon rains, land clearing cannot be avoided and soil erosion take place during the construction period. Soil erosion along the bund slopes were taken place before placing riprap protection and turfing until roots of turf are firmly grown .

**Fig 5: Riprap protection in the bund**

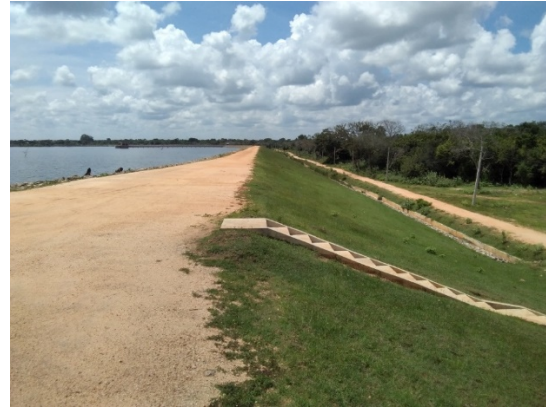
**Fig 6: Turfing protection in the bund**

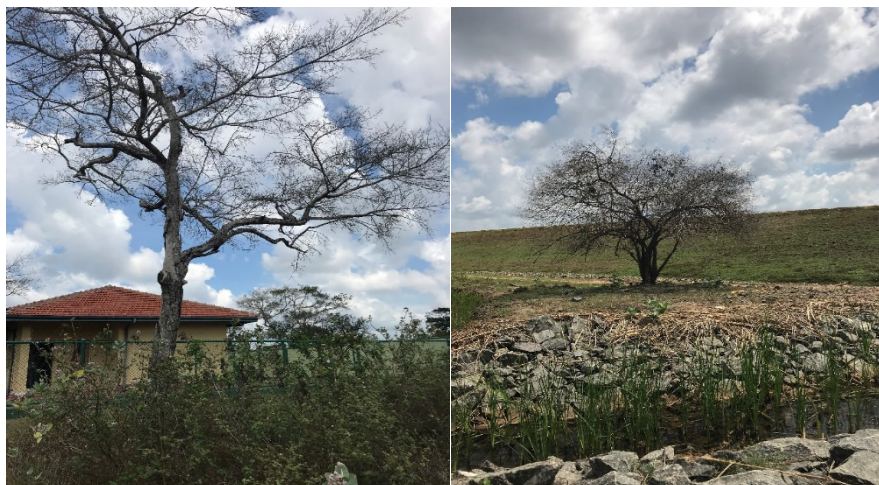
It was observed during the study that the trees closer to the dam at the downstream are dying which may be due to the water level dropped (Fig 7). Around ten trees were affected at the downstream. This impact was not anticipated and as a result no mitigation measures had been proposed in the EIA and subsequent monitoring reports. This study recommends investigating this impact by an ecologist to find out the root cause and to propose mitigations measures.

**Fig 7: Dying trees**

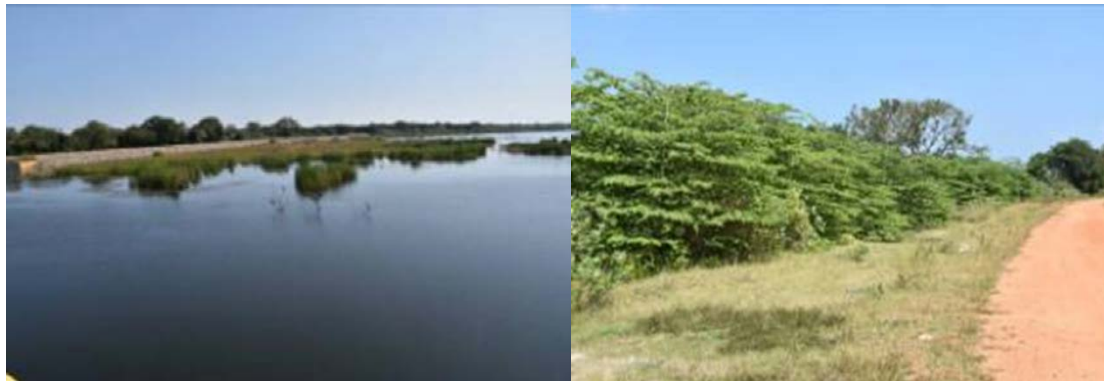
The EIA has anticipated three invasive species in the reservoirs and streams might have spread which were *Salvinia* (*Salvinia molesta*), *water hyacinth* (*Eichhornia crassipes*) and *Mimosa pigra* (*Giant Sensitive plant*). This study revealed that two invasive plant namely *Typha angustifolia* (narrow leaf cattail) and *Muntingia calabura* (Jam fruit tree) are spreading in the reservoir area (Fig. 9).

Fig. 9: Spreading of invasive plants in the reservoir and on road sides.

Jam fruit trees are grown commonly in home gardens, street and listed as potentially invasive as it can spread rapidly in disturbed habitats as that will arise during construction of roads, reservoirs etc., The plant bears a berry that is used as food by many birds species, which functions as seed dispersal agents of this plant. Thus, it can spread rapidly once established (ADB, 2018a). This study recommends to take steps to remove and control the spread of these invasive alien plant species.

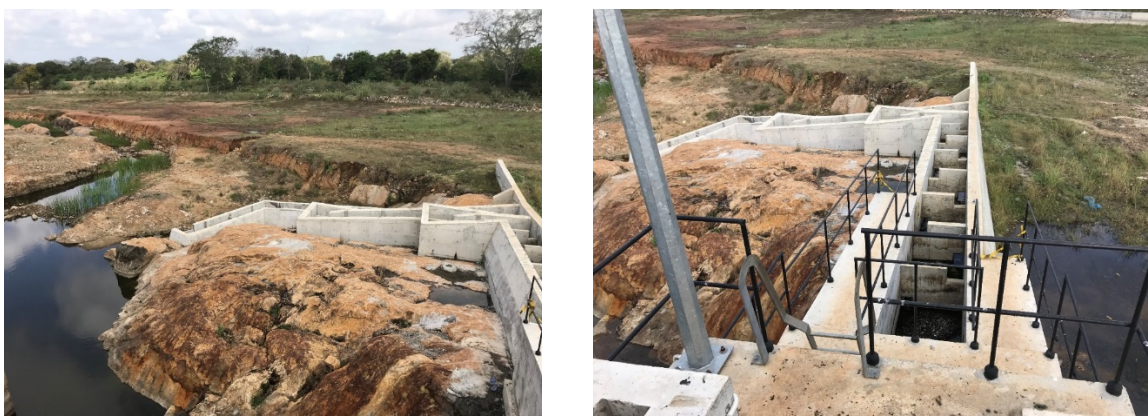
A fish ladder was constructed for migrant fishes (Fig. 10). The fish ladder contains a series of interconnected water pooling units. The speed of the water flow has been reduced by providing a mild bed slope, speed breakers alternative at right and left sides, and bedding material with coarse rock media. This enables fish species to move upstream against the water flow.

Fig. 10: Constructed fish ladder

**5.5 Fish Ladder :** The spillway and the fish ladder should be strictly maintained as a no fishing zone as fish are easily captured by the villagers at these two locations which would reduce the conservation value of including a fish ladder for the dam. The construction of fish ladder mouth closer to the spillway might have happened due the lack of historic information about the functionality, subsequent problems, shortcomings. It is recommended to design the fish ladder for this kind of project at the beginning. Also it is recommended to extend the length of the fish ladder further down. The flow speed in the fish ladder should be kept at a minimum level which will facilitate make it easier for the fish to travel upstream in the fish ladder without becoming fatigued. It is advisable to use small boulders instead of small concrete metal in the bottom surface of the fish leader which will prevent this situation from arising as well as make it easier for fish to move through the fish ladder. Fish hatcheries can be considered as an option. Fish hatcheries try to compensate for fish stocks affected by dams

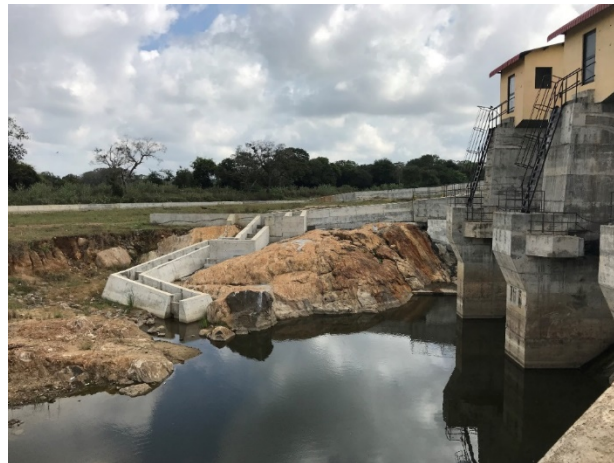
This study revealed that the fish ladder was constructed closer to the spillway since the fish tend to get confused between the spillway and the entrance to the fish ladder and attempts to scale the spillway which causes injury to fish (Fig 11). The construction of fish ladder closer to the spillway might have happened due the late design of fish ladder in the later stage.

**Fig 11: Construction of fish ladder closer to the spillway**

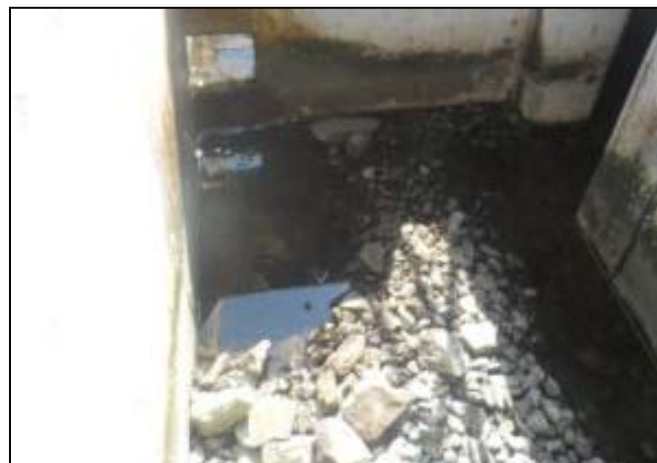
The study reported by ADB, (2018a) on this project indicated that concrete metal has been used to cover the bottom surface of the fish ladder which tend to get shifted when water is flowing in the ladder creating small pools where fish get trapped when the fish ladder stop operating (Fig 12). These small pools are subjected to high temperature fluctuations and high rate of predation by birds.

**Fig. 12: Water pools created by concrete metal**

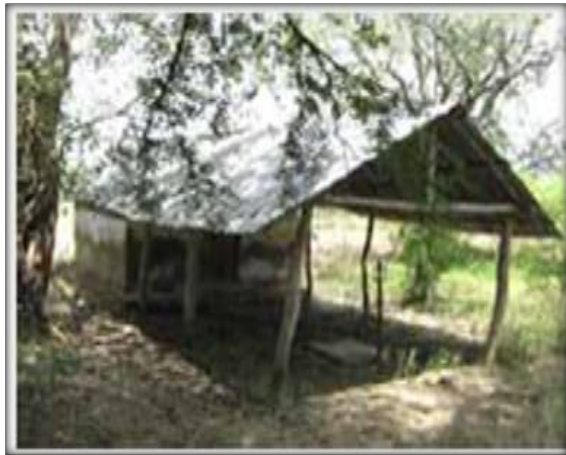
The only building of historic, cultural or religious significance was the Hindu kovil located in the Periyakulam area (Fig 18). This had been in existence for some time and the incumbent was very concerned that the kovil was not to be relocated. Therefore the kovil was rebuilt at the same premises at a higher elevation (Fig 19).

Fig 18: Old Hindu kovil

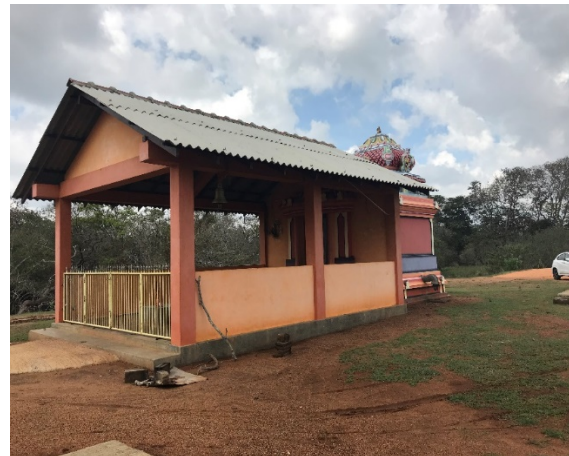
Fig 19: Newly Built Kovil
