# Mesh Materials Used for Hernia Repair: Why Do They Shrink?

**Abstract:** Eleven hernia repair meshes implanted for up to 4 years were harvested at reoperation: 9 recurrences, 1 infection, and 1 infection associated with a fistula. They were made of polypropylene (PP) fabric and/or expanded polytetrafluoroethylene (ePTFE). The devices shrank considerably from 12 to 53% with heavy fibrotic embedding. This shrinkage occurred due to the contraction of the fibrotic tissues that penetrated through the materials and encroached all the polymer structures. The level of inflammation was aggravated in the case of oxidation of the external surface of the PP fibers. Multiple flaking led to detachment of PP particles. In addition, the collagen bundles in the scar tissue did not show any waviness, and thus could be considered as responsible for the lack of elasticity of the encapsulating tissues. Furthermore, particles from the ePTFE structures were occasionally identified dispersed in peri-implant tissues. Despite the plethora of devices commercially available, there is still no consensus about the most appropriate one. Future hernia mesh devices should reduce fibrotic encapsulation and encou

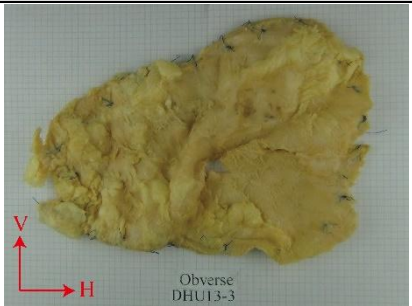
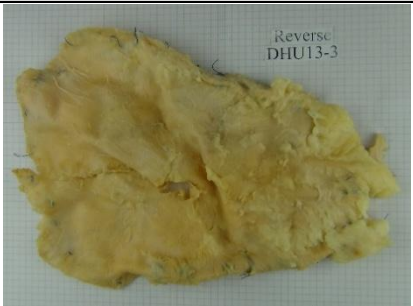
| Code | Explants | | Implant size (cm) | Explant size (cm) | Shrinkage in each direction (%) | Implant surface (cm <sup>2</sup> ) | Explant surface (cm <sup>2</sup> ) | Shrinkage (%) | Explant weight (g) |
|---|---|---|---|---|---|---|---|---|---|
| DHU13-3 | | | H: 32.00* | H: 26.00 | H: 42.22 | 640.00* | 386.92 | 39.54 | 167.86 |
| | | | V: 20.00* | V: 18.00 | V: 21.74 | | | | |

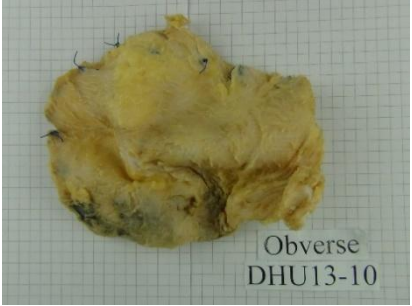
| Code | Explants | | Implant size (cm) | Explant size (cm) | Shrinkage in each direction (%) | Implant surface (cm <sup>2</sup> ) | Explant surface (cm <sup>2</sup> ) | Shrinkage (%) | Explant weight (g) |
|---|---|---|---|---|---|---|---|---|---|
| DHU13-10 | | | H: 14.00* | H: 13.00 | H: 7.40 | 182.00* | 98.81 | 45.60 | 49.45 |
| | | | V: 13.00* | V: 10.00 | V: 20.00 | | | | |

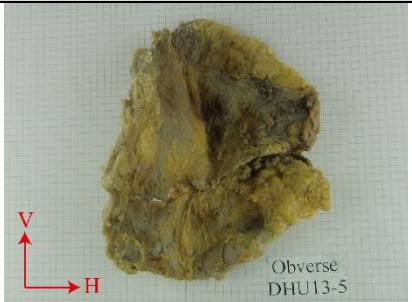
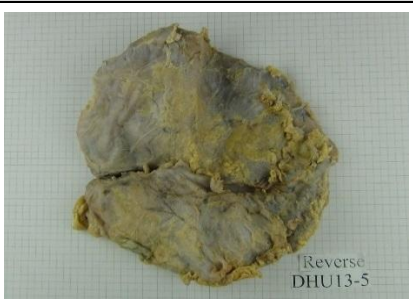
**Table S1B: Observation of the explanted devices: Two layers of PP mesh**

| Code | Explants | | Implant size (cm) | Explant size (cm) | Shrinkage in each direction (%) | Implant surface (cm <sup>2</sup> ) | Explant surface (cm <sup>2</sup> ) | Shrinkage (%) | Explant weight (g) |
|---|---|---|---|---|---|---|---|---|---|
| DHU13-5<br>(1427 days) | | | H: 23.50* | H: 19.00 | H: 19.14 | 433.51* | 214.62 | 50.49 | 154.44 |
| | | | V: 23.50* | V: 17.50 | V: 25.53 | | | | |

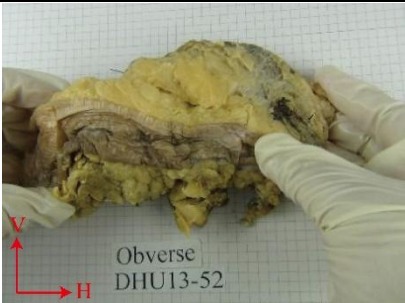
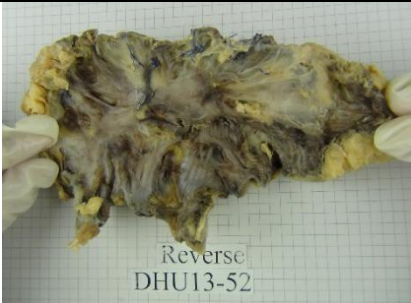
**Table S1C: Observation of the explanted devices: double-layer PP with 3-dimensional structure**

| Code | Explants | | Implant size (cm) | Explant size (cm) | Shrinkage in each direction (%) | Implant surface (cm <sup>2</sup> ) | Explant surface (cm <sup>2</sup> ) | Shrinkage (%) | Explant weight (g) |
|---|---|---|---|---|---|---|---|---|---|
| DHU 13-52 | | | H: 22.00* | H: 19.50 | H: 15.55 | 352.00* | 113.57 | 67.73 | 138.00 |
| | | | V: 16.00* | V: 13.00 | V: 28.57 | | | | |

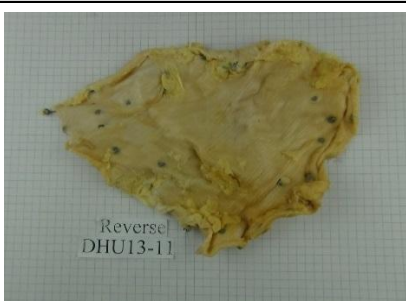
**Table S1D: Observation of the explanted devices: Single ePTFE membrane**

| Code | Explants | | Implant size (cm) | Explant size (cm) | Shrinkage in each direction (%) | Implant surface (cm <sup>2</sup> ) | Explant surface (cm <sup>2</sup> ) | Shrinkage (%) | Explant weight (g) |
|---|---|---|---|---|---|---|---|---|---|
| DHU13-11<br>(1035 days) | | | H: 22.00* | H: 19.50 | H: 11.36 | 330.00* | 165.83 | 49.75 | 82.42 |
| | | | V: 15.00* | V: 13.00 | V: 13.33 | | | | |

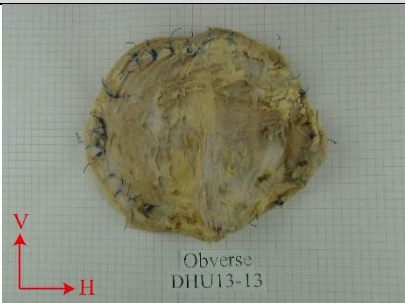
**Table S1E: Observation of the explanted devices: One layer of PP mesh + ePTFE membrane**

| Code | Explants | | Implant size (cm) | Explant size (cm) | Shrinkage in each direction (%) | Implant surface (cm <sup>2</sup> ) | Explant surface (cm <sup>2</sup> ) | Shrinkage (%) | Explant weight (g) |
|---|---|---|---|---|---|---|---|---|---|
| DHU13-13<br>(558 days) | | | H: 18.00 | H: 16.00 | H: 11.11 | 197.82 | 156.81 | 20.73 | 58.12 |
| | | | V: 14.00 | V: 12.00 | V: 14.29 | | | | |

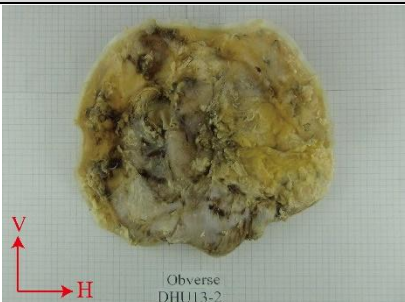
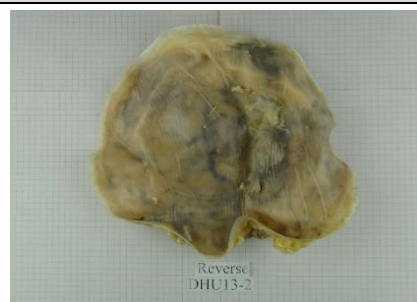
**Table S1F(A): Observation of the explanted devices: Two layers of PP mesh + ePTFE**

| Code | Explants | | Implant size (cm) | Explant size (cm) | Shrinkage in each direction (%) | Implant surface (cm <sup>2</sup> ) | Explant surface (cm <sup>2</sup> ) | Shrinkage (%) | Explant weight (g) |
|---|---|---|---|---|---|---|---|---|---|
| DHU13-2<br>(1050 days) | <br>Obverse<br>DHU13-2 | <br>Reverse<br>DHU13-2 | H: 24.60 | H: 22.00 | H: 10.57 | 378.50 | 299.05 | 20.98 | 102.36 |
| | | | V: 19.60 | V: 19.00 | V: 3.06 | | | | |

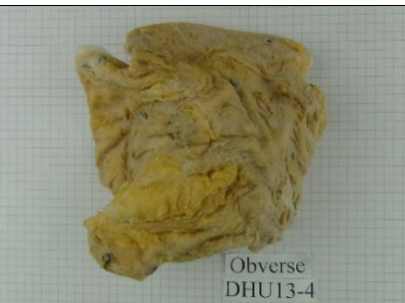
| Code | Explants | | Implant size (cm) | Explant size (cm) | Shrinkage in each direction (%) | Implant surface (cm <sup>2</sup> ) | Explant surface (cm <sup>2</sup> ) | Shrinkage (%) | Explant weight (g) |
|---|---|---|---|---|---|---|---|---|---|
| DHU13-4 | <br>Obverse<br>DHU13-4 | <br>Obverse<br>DHU13-4 | H: 25.00 | H: 18.00 | H: 28.00 | 500.00 | 162.29 | 67.54 | 145.66 |
| | | | V: 20.00 | V: 13.00 | V: 35.00 | | | | |

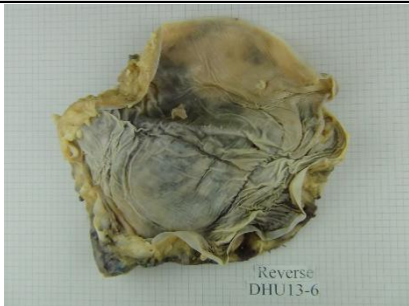
**Table S1F(B):** Observation of the explanted devices: Two layers of PP mesh + ePTFE membrane

| Code | Explants | | Implant size (cm) | Explant size (cm) | Shrinkage in each direction (%) | Implant surface (cm <sup>2</sup> ) | Explant surface (cm <sup>2</sup> ) | Shrinkage (%) | Explant weight (g) |
|---|---|---|---|---|---|---|---|---|---|
| DHU13-6 | | | H: 32.50* | H: 24.00 | H: 26.15 | 731.25* | 294.66 | 59.70 | 177.18 |
| | | | V: 22.50* | V: 18.00 | V: 20.00 | | | | |

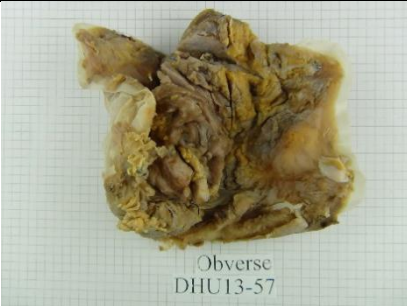
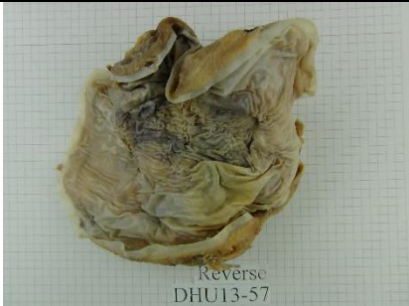
| Code | Explants | | Implant size (cm) | Explant size (cm) | Shrinkage in each direction (%) | Implant surface (cm <sup>2</sup> ) | Explant surface (cm <sup>2</sup> ) | Shrinkage (%) | Explant weight (g) |
|---|---|---|---|---|---|---|---|---|---|
| DHU13-57 | | | H: 19.60 | H: 16.00 | H: 18.37 | 482.16 | 165.83 | 65.61 | 152.44 |
| | | | V: 24.60 | V: 13.00 | V: 47.15 | | | | |

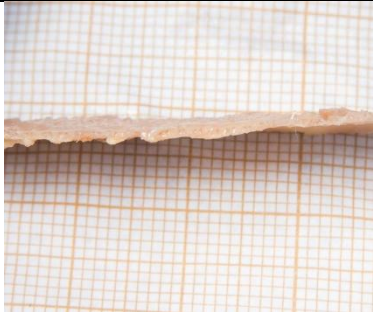
**Table S2A:** Histology of the explanted devices: One layer of PP mesh

| Code | Cross section | Histology | | |
|---|---|---|---|---|
| DHU13-7<br>(141 days) | | | | Widespread fibrosis with hyalinosis; moderate macrophage infiltration around the fabric; diffuse lymphocyte infiltration with haemorrhages; minimal giant cell reaction; foam cell occurrence; foci of necrosis; presence of fungi debris? |

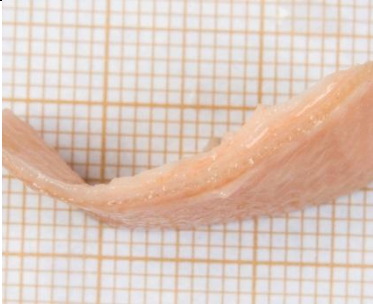
| Code | Cross section | Histology | | |
|---|---|---|---|---|
| DHU13-10 | | | | Fibrosis with perivascular macrophage and lymphocyte infiltration; moderate giant cell reaction; moderate outgrowth of granulations; some debris of fiber along the encapsulation. |

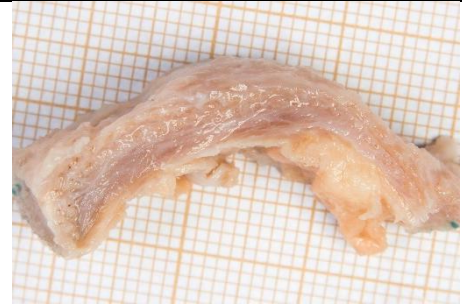
**Table S2B:** Histology of the explanted device: Two layers of PP mesh

| Code | Cross section | Histology | | |
|---|---|---|---|---|
| DHU13-5<br>(1427 days) | | | | Widespread fibrosis with infiltration of macrophages low to moderate; Minimal giant cell reaction. |

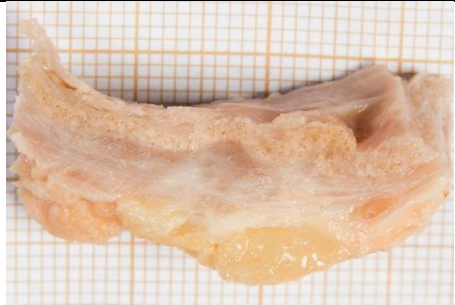
**Table S2C: Histology of the explanted device: Two layers of PP mesh with 3-dimentional structure**

| Code | Cross section | Histology | | |
|---|---|---|---|---|
| DHU13-52 | | | | Significant fibrosis with macrophages and lymphocytes; moderate giant cell reaction and granulations. |

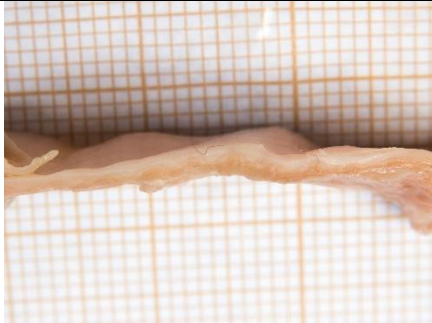
**Table S2D: Histology of the explanted device: Single ePTFE membrane**

| Code | Cross section | Histology | | |
|---|---|---|---|---|
| DHU13-11<br>(1035 days) | | | | Intimate anchorage of the capsule with the ePTFE film and detachment of some nodule of the film within the fibrous capsul; very intensive giant cell reaction with fibrosis; Peri-implant macrophages and lymphocyte infiltration. |

DHU 13-11 (single layer ePTFE) was the sole explant that illustrated the biological integration between abdominal wall and ePTFE membrane. The micropores in ePTFE permitted collagen infiltration (Fig. 3C, 3D, Table S2D, Table S3D). The collagen fibers at the interface of the ePTFE showed a tight and straight structure devoid of any waviness. In

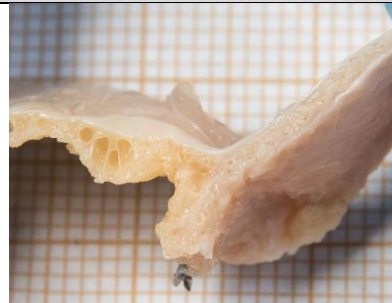
**Table S2F(A) : Histology of the explanted devices: Two layers of PP mesh + ePTFE membrane**

| Code | Cross section | Histology | | |
|---|---|---|---|---|
| DHU13-2<br>(1050 days) | | | | The PTFE is detached from the tissue encapsulated mesh (arrow); the fibrous capsule is infiltrated with minimal giant cells and lymphocytes around the textile fibers with evident fibrosis. |

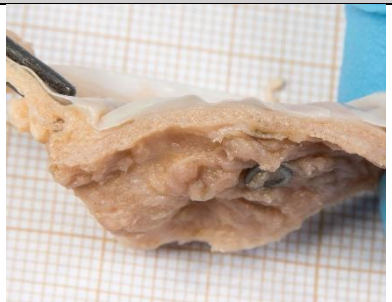
**Table S2F(B) : Histology of the explanted devices: Two layers of PP mesh + ePTFE membrane**

| Code | | Cross section | Histology | |
|---|---|---|---|---|
| DHU13-6<br>(600 days) | | | | Poorly anchored film to the fibrous encapsulation of the fabric. Macrophages and lymphocytes are surrounding the textile fiber with debris of the polymer visible. Haemorrhages (arrows) and necrotized foci. |

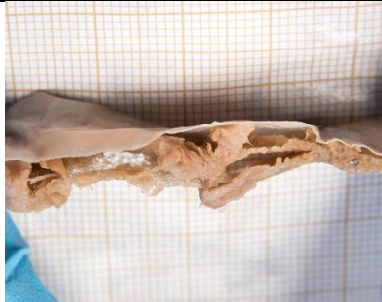
| DHU13-57 | | | | ePTFE film totally detached. Capsule with large fibrous areas. Significant lymphocyte infiltration surrounding the fiber of the fabric. Significant occurrence of granulation and necrotized areas (arrows). |
