# The Degree of Success in Environmental Mitigation Measures of Development Projects in Sri Lanka with Special Reference to Peraru Water Supply and Sanitation Project

Y.B.M. Asmi<sup>1</sup> and T.K. Weerasinghe<sup>2</sup>

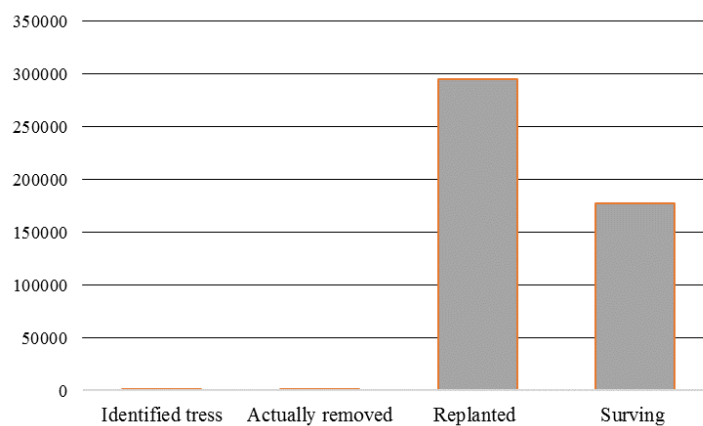
**Fig 4: Comparison of removed and planted trees**

It was noted a total of 1600 mature trees namely *Kumbuk (Genera terminalia Arjina)*, *Palu (Manikara hexandra)*, *Weera (Drypetes sepiaria)* and other few were removed. EIA identified a total of 1559 mature trees to be removed in the same species. The project had taken a steps to plant a total of 295,000 plants at 162.16 ha . Based on the available survival records only 60% of 176,972<sup>6</sup> plants are surviving (Fig 4). The study reported by IUCN, (2007) on the Moragahakanda Agricultural Development Project indicated that survival of transplanted species was 84%.

<sup>6</sup> After the project completion in September 2016, there were no maintenance for the planted plants. Researcher couldn't take the survival of plants during the field study as the area with full of bushes and scrub. There is no access to the area. The data used here is from the contractor's invoice in January 2016. The planted plants are composition of upper canopy and under story.

It was noted that the forest enrichment programme, which is the mitigation measure proposed in the EIA to enhance the overall carrying capacity of the area for species that would compensate for the loss of forest that taken place under the project has been completed successfully.

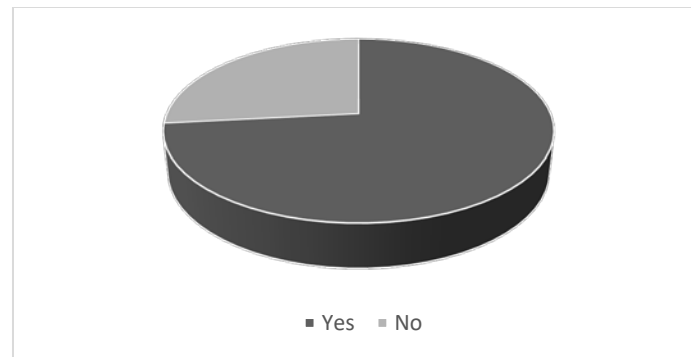
**Fig 13: Water table changes**

The project had changed the water table of the area. While interviewing the people, Seventy three percent of the people living in the study area of the upstream had observed the water level in their well has been increased by 1-2 feet after the reservoir construction and continually having the adequate water in their well in the dry season (March – September) period (Fig 13). But twenty seven percent of the people have not observed any fluctuation or changes in the water table. The people living in the downstream observed the water level in their well has gone down during summer but continually having the water than before the reservoir construction.

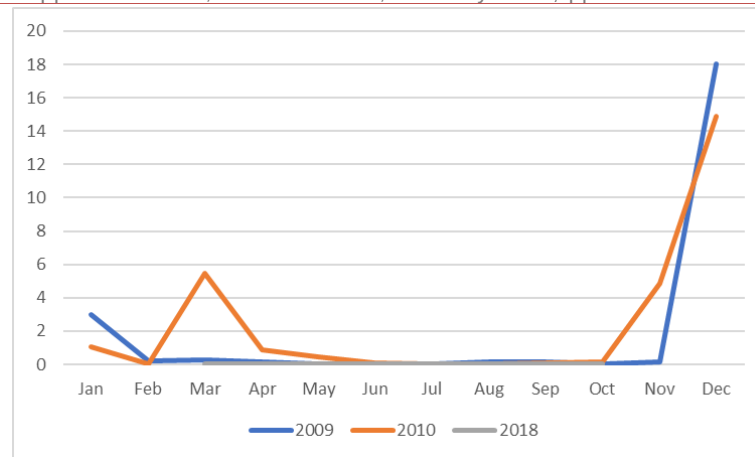
**Fig 14: Monthly average stream flow (m³/sec) (EIA, 2012b)**

Peru Aru is not a perennial river. The EIA had recommended to maintain continuous downstream flow throughout the year. The study revealed that the water flow was not stopped during the construction. A diversion canal was constructed during the construction to allow the stream flow without any interruption. This study reveals that operating arrangements have not been performed to release the environmental flow after the construction. People living at the downstream too confirmed that they have not observed any flow of water during the dry spell in the river. The project team believed that the seepage water from the reservoir is enough to meet the environmental flow requirement (Fig 14). The perception of the NWSDB is not justifiable against the concept of the environmental flow. The proposed continuous flow in EIA has not been complied.

**5.2 Environmental Flow:** NWSDB has not released the environmental flow as per the NEA and EIA recommendation of the project. The matter was not raised by any parties after the project completion, other than ADB. Therefore, it is recommended to monitor as raised by the ADB, irrigation department and Department of Agriculture to ensure the e-flow. As per the EIA, one species (*Labeo dussumieri*)
